Pyrrhotite in Concrete Aggregates

Is legislation ahead of science?

by Anthony F. Bentivegna, April Snyder, and Stephen M. Stacey

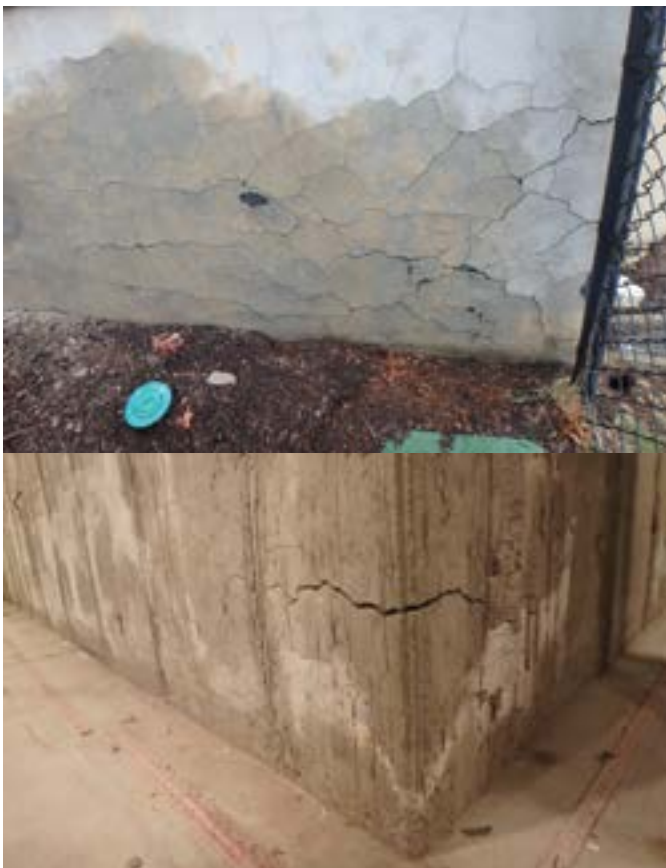
Fig. 1: Typical indications of pyrrhotite deterioration in concrete foundations

Concrete aggregates produced in two regions in North America have been identified as the cause of deterioration to tens of thousands of residential and light commercial concrete foundations. These concrete foundations have experienced extensive cracking and loss of structural integrity due to an oxidation reaction of an iron sulfide mineral, pyrrhotite (Fig. 1). No methods for mitigating

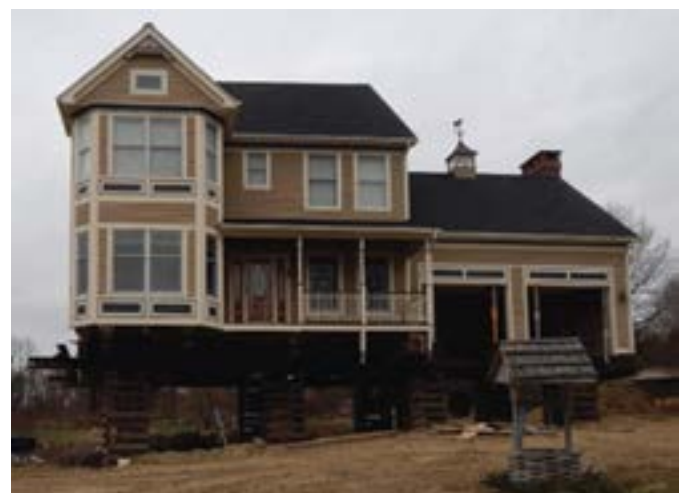
Fig. 2: Replacement of residential foundation in Connecticut (photo courtesy of U.S. Government Accountability Office)

the reaction or repairing the compromised foundations have been successful. The only effective technique has been to lift the houses off their existing foundations and remove and replace the concrete (Fig. 2).

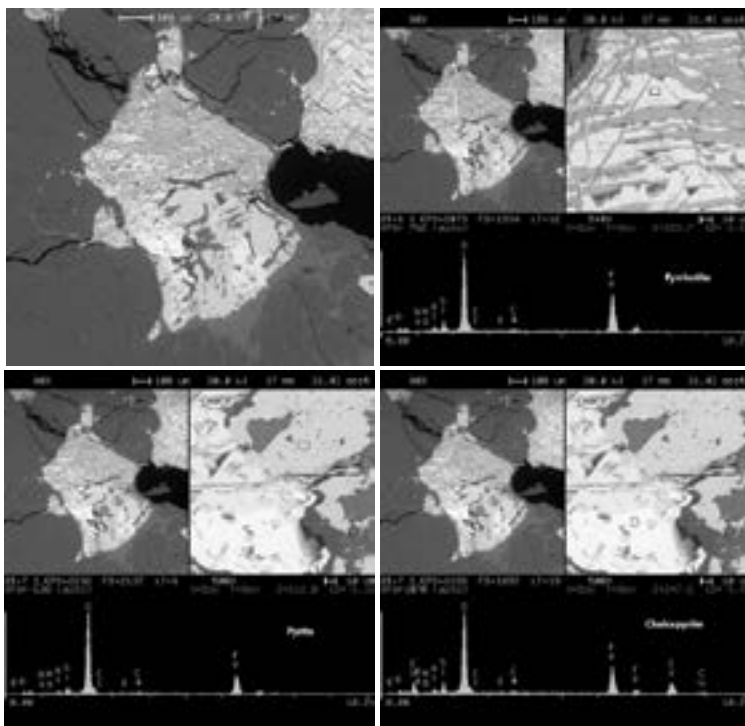
Fig. 3: Scanning electron microscope (SEM) backscattered electron (BSE) images with EDS spectra of occurrence of iron sulfides in concrete aggregate with pyrrhotite showing corrosion

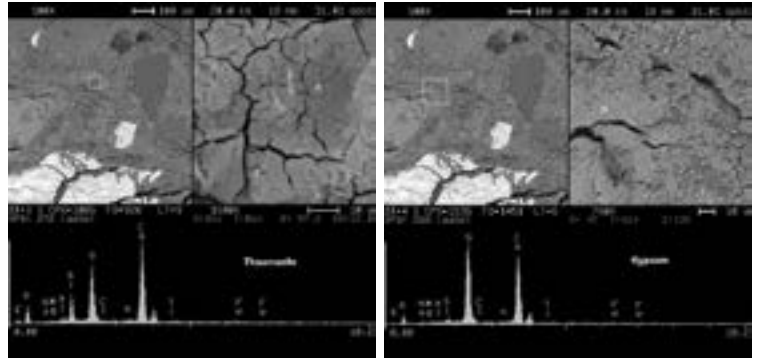
Fig. 4: BSE SEM images with EDS spectra of deleterious secondary minerals formed in the calcium silicate hydrate (paste) adjacent to corroded pyrrhotite-containing aggregate

- Secondary mineralization—Sulfuric acid is produced as a by-product of the oxidation reaction. The sulfuric acid lowers the pH and reacts with a portland cement hydration product, portlandite ($\text{Ca}(\text{OH})_2$), to form gypsum ($\text{CaSO}_4 \cdot 2\text{H}_2\text{O}$). Gypsum reacts with the anhydrous or hydrated aluminate phases in portland cement to form expansive ettringite ($\text{Ca}_6\text{Al}_2(\text{SO}_4)_3(\text{OH})_{12} \cdot 26\text{H}_2\text{O}$).^{8,9} If the concrete has a source of limestone (CaCO_3), either from aggregate, cement, or another source, thaumasite ($\text{Ca}_3\text{Si}(\text{OH})_6(\text{CO}_3)(\text{SO}_4) \cdot 12\text{H}_2\text{O}$) can be formed.³ Backscatter images of the expansive reaction products are shown in Fig. 4.

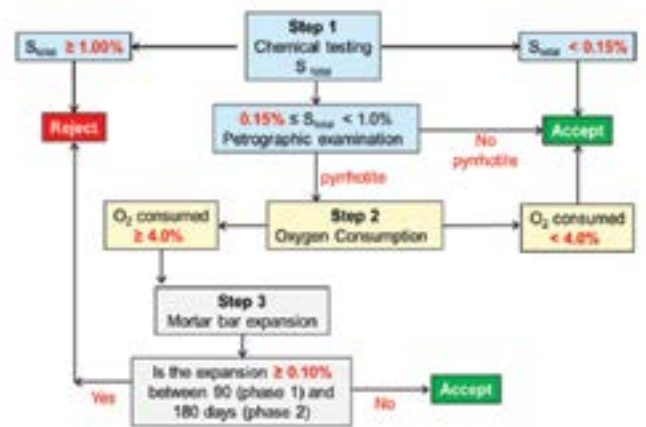
Fig. 7: CSA protocol for determining the potential reactivity of iron sulfide-bearing aggregates in Annex P of CSA A23.1:19/CSA A23.2:19^{15,16}

In Canada, CSA A23.1:19/A23.2:19 includes an informative Appendix P—“Impact of sulphides in aggregate on concrete behavior and global approach to determine potential deleterious reactivity of sulphide-bearing aggregates.”¹⁵ This annex recommends using a three-step process for evaluating an aggregate: (1) quantifying the amount of sulfide sulfur content; (2) evaluating the oxidation potential; and (3) evaluating the potential reactivity in concrete (mortar bars). These test methods have proved successful in identifying the potential for deleterious reaction in foundations, but validation over a wide range of aggregate types is in progress. The oxidation and expansion test methods are onerous and preliminary evaluations of the methods indicate high variability of results. The CSA document provides guidance based on the tests, which is summarized in the flow chart (Fig. 7).¹⁶
